Manhole Inspection Summary

Manhole # S53M__041MH

Location Address: **rear 913 s ellwood av**

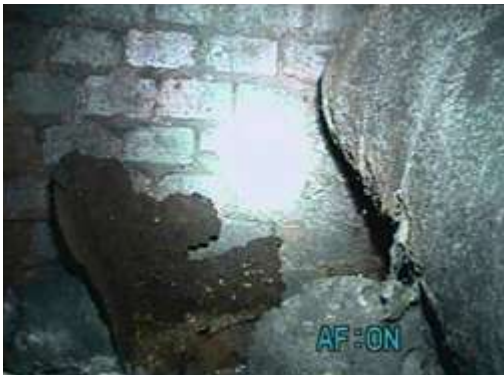
Defect 2

Condition: ☐ Sound ☐ Cracked ☐ Root Intrusion ☐ Deteriorated ☐ Leaks ☒ **Debris**

channel debris

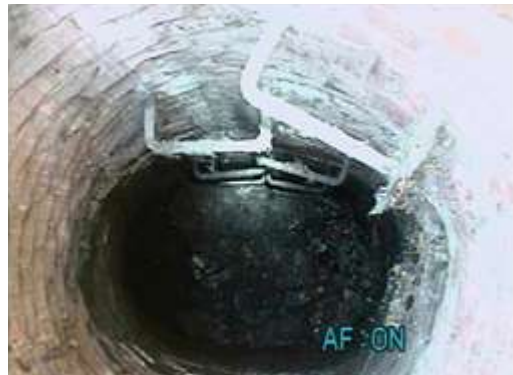
Defect 1

Steps Count: **7** Missing: **0** ☒ **Corroded**

Surcharge ☒ **Evidence Of Surcharge** Depth: **8.** (ft.) ☐ Active Surcharge Present

steps & surcharge evidence

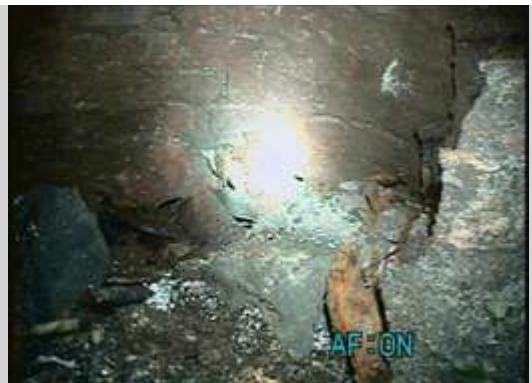
12 O'Clock Outflow

8 in. Circular Gravity Sewer
Pipe Out @ 12 O'Clock

blocked by debris
